**PRE-REHABILITATION  
ASBESTOS-CONTAINING MATERIALS, LEAD AND PCBS  
INSPECTION REPORT**

**SAWKILL RUBY ROAD (CR-90) BRIDGE OVER I-87 AT MP 95.27  
BIN 5515540  
TOWN OF ULSTER, ULSTER COUNTY, NEW YORK  
DESIGN CONTRACT D214817**

***HUNT*** ENGINEERS | ARCHITECTS | SURVEYORS

**Conditions as of October 2025**

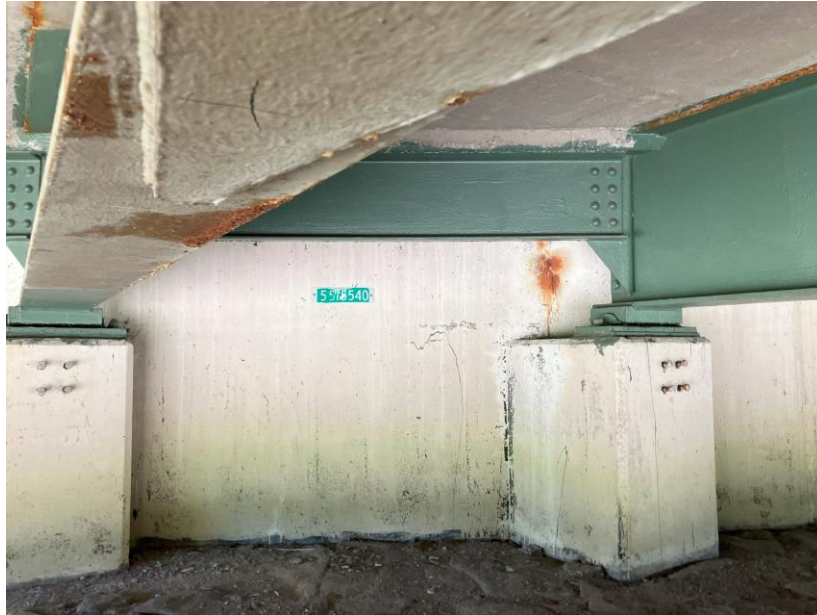
**Photo Number:** 2

**Photo Description:** BIN plate and white abutment paint (BS-26).

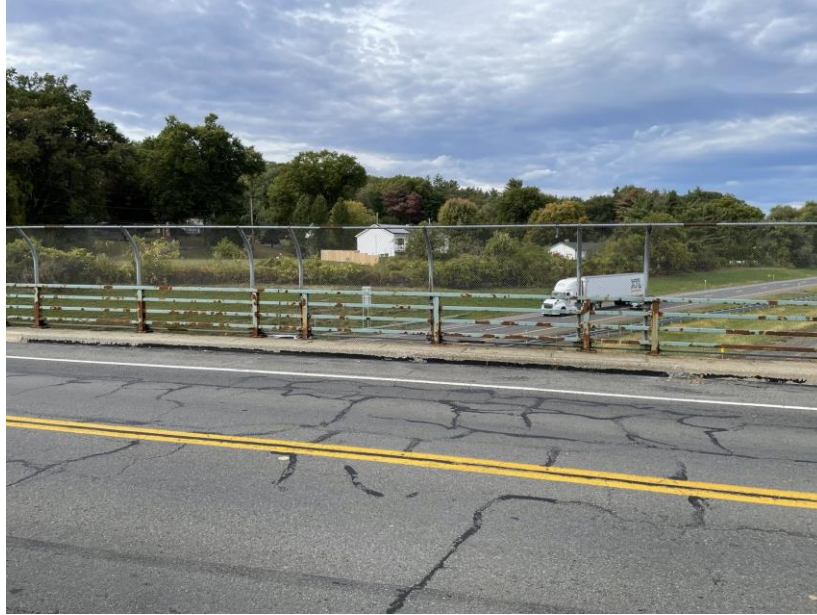
**Photo Number:** 6

Given the date of the structure (reportedly built in the 1950s) and known use of lead paint at that time, all painted surfaces shall be assumed to be lead based. Paint samples were not collected per NYSTA policy. At the time of sampling, five (5) painted surfaces were noted including: light blue railing paint, green girder paint, dark green paint, off-white girder paint, and white column abutment paint.

**Photo Description:** Light blue railing paint (BS-1, BS-2, & BS-3).

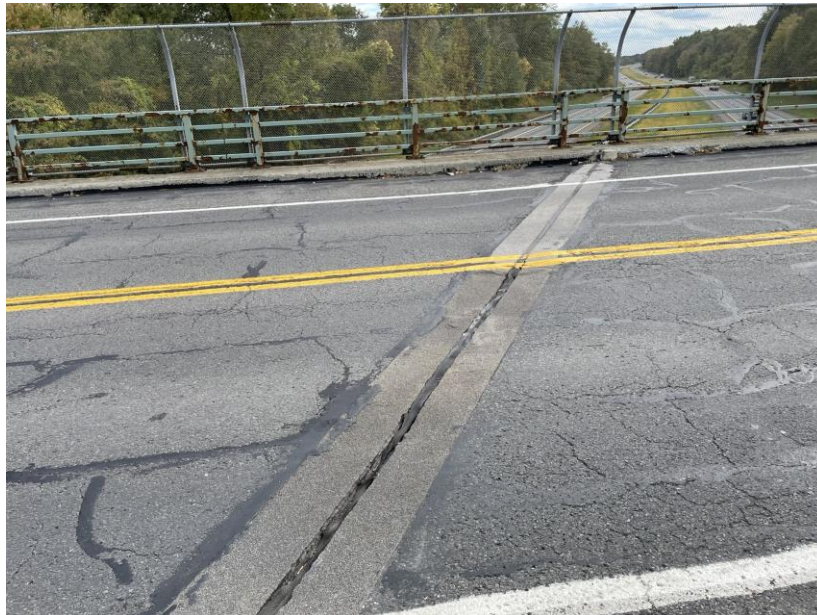
**Photo Number:** 7

USEPA recognizes that caulks and sealants are suspected of containing PCBs. HUNT understands that it is not NYSTA policy to sample PCBs; however, sampling may be required to facilitate proper disposal. At the time of sampling, one (1) suspect PCB-containing material was noted. The PCB sample was sent to Paradigm Environmental Services, Inc located in Rochester New York. The sample (gray caulk) was determined to be non-PCB containing.

**Photo Description:** Gray expansion joint caulk (BS-8, BS-9, & BS-10 and PCB Sample #254776-03).

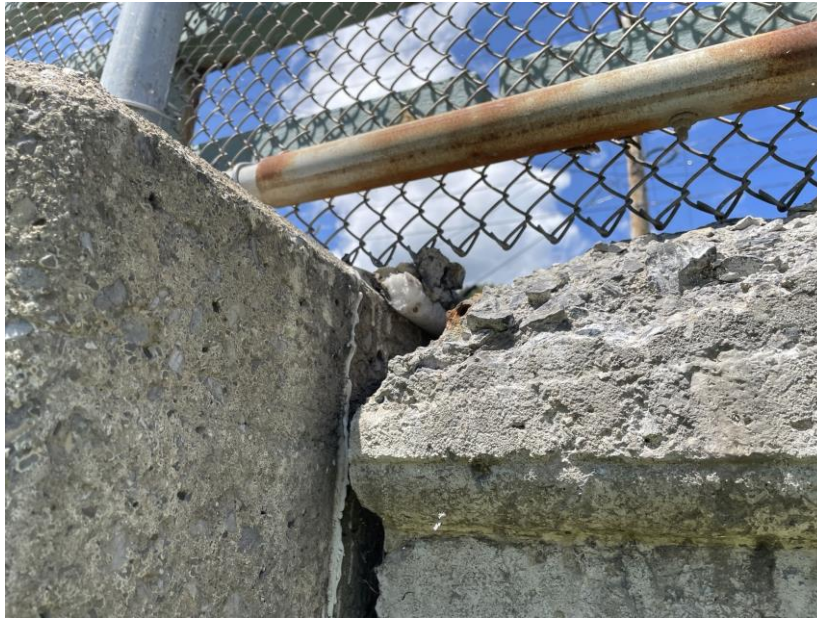
**Photo Number:** 8

**Photo Description:** Foam beneath expansion joint caulk (BS-11, BS-12, and BS-13).

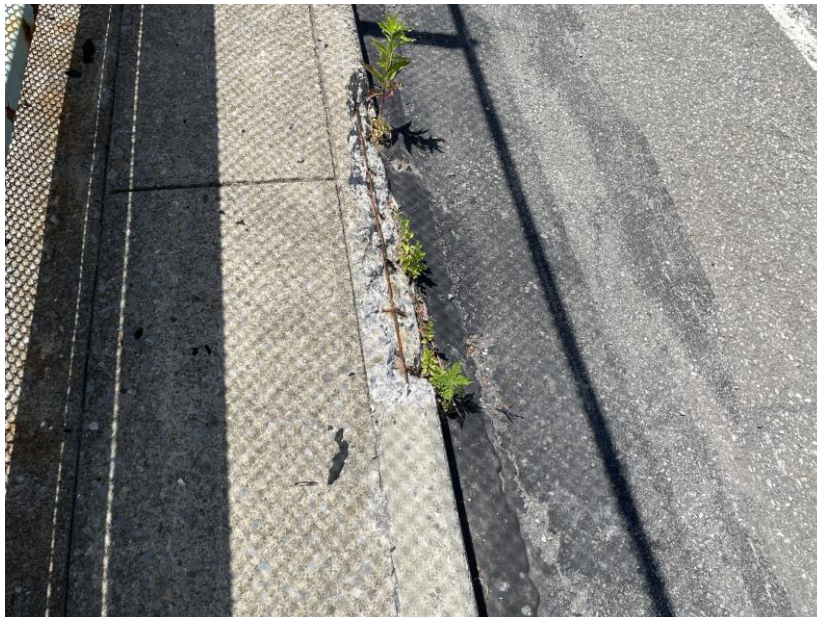
**Photo Number:** 9

**Photo Description:** Black asphaltic tar (BS-14, BS-15 & BS-16) along concrete sidewalks (BS-5, BS-6, & BS-7).

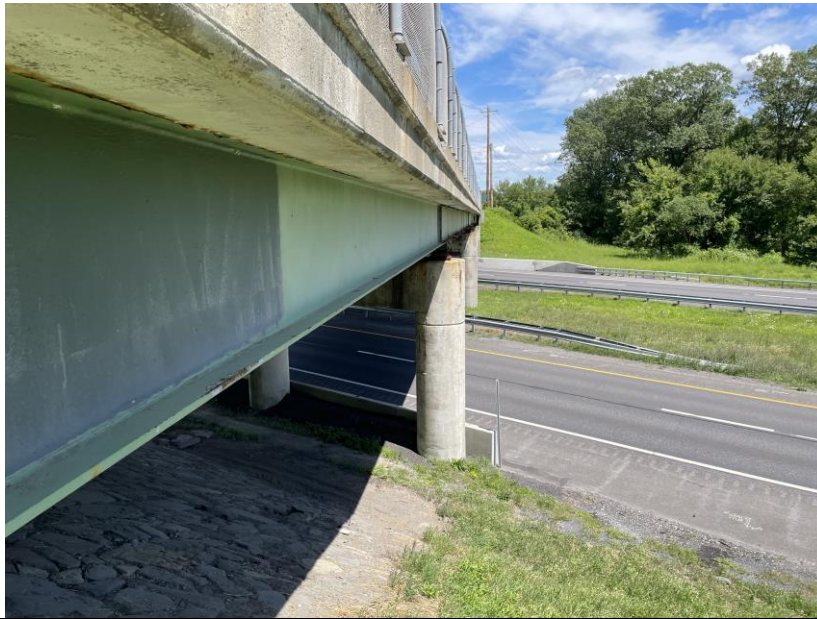
**Photo Number:** 10

**Photo Description:** Dark green abutment paint (BS-20, BS-21, & BS-22) and lighter green girder paint (BS-17, BS-18, & BS-19).

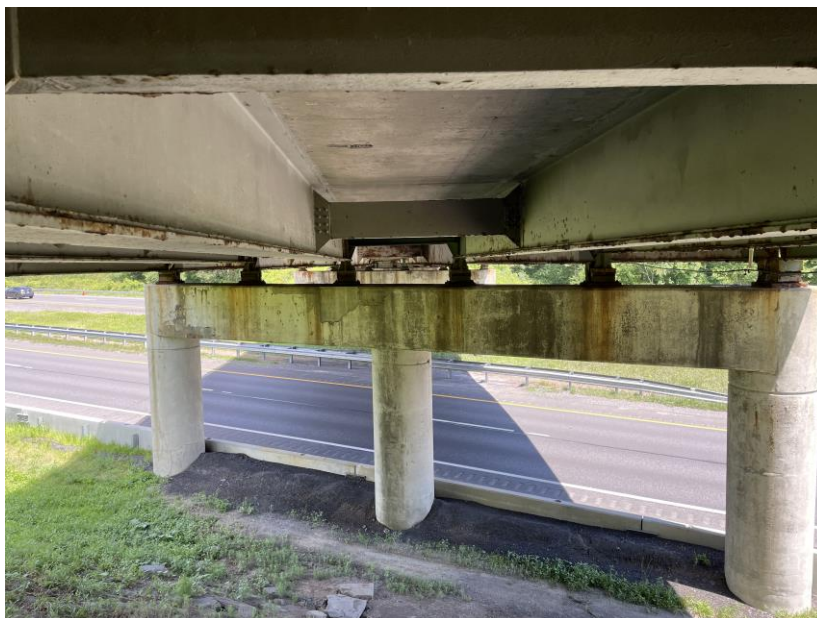
**Photo Number:** 11

**Photo Description:** Off white girder paint (BS-23, BS-24, & BS-25), white column/abutment paint (BS-28), and column/pillar concrete (BS-29, BS-30, & BS-30).

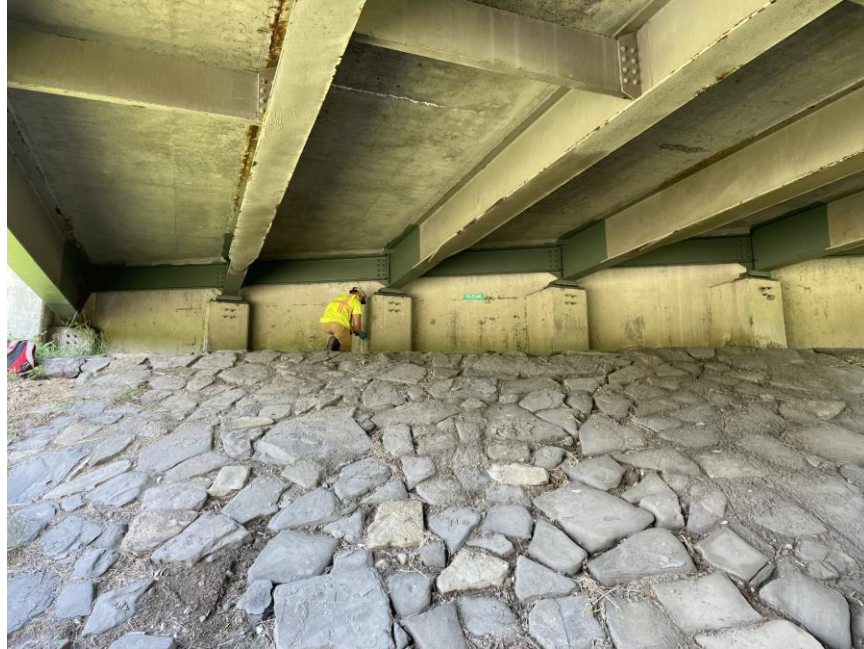
**Photo Number:** 12

Based on laboratory analysis, no ACM was identified in nine (9) of the ten (10) HA materials sampled during the inspection and testing activities. However, one sample (Sample BS-27), described as white column/abutment paint, detected chrysotile asbestos (5.4%). This material was noted to be non-friable and in fair condition. HUNT estimates approximately 400 square feet of the material exists on the eastern bridge abutment. According to record documents received from the NYSTA (FACT 50-1, TA 00-70F, TAA 77-14BP, TAA 90-26BP), it is expected the paint on these surfaces is from original construction, as only painting and cleaning of structural steel are noted as bridge improvements.

**Photo Description:** Eastern abutment, sample collection of BS-27 (ACM).

Based on the information presented in this report, as part of the upcoming bridge rehabilitation, asbestos abatement of the materials identified as ACM will require abatement by a NYS licensed asbestos abatement contractor. Asbestos abatement design specifications will also be required by a NYS Asbestos Designer. Included in the design specifications, the project designer should utilize Bridge Variance 14 Removal of Miscellaneous Non-Friable Asbestos Containing Materials as part of the asbestos abatement specifications.
