**Re: Limited Pre-Rehabilitation Asbestos Containing Materials Inspection Report  
Mariaville Road Bridge over NYS Thruway I-87 Rehabilitation  
Town of Rotterdam, Schenectady County, New York**

# PHOTOGRAPHIC DOCUMENTATION

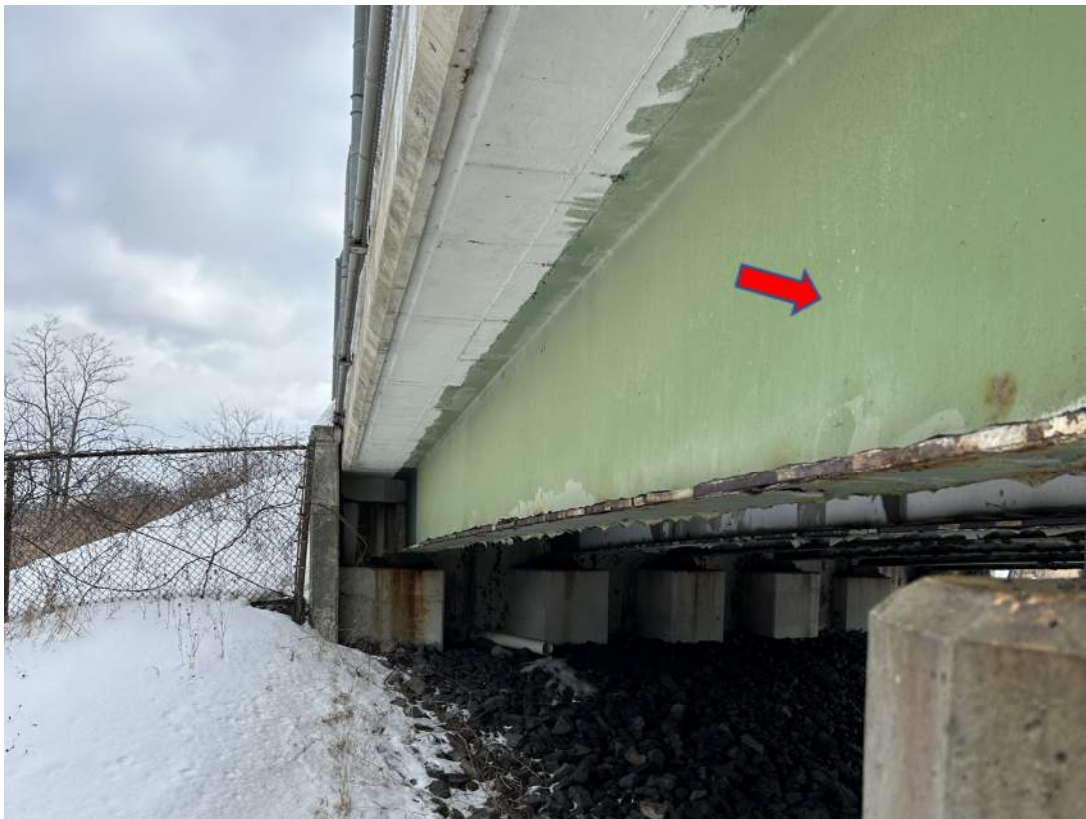
Photograph 1 – View of bridge inner girders non-ACM green paint (ACM-1, ACM-2 & ACM-3).

| Sample ID | Percent (%) Asbestos |
|---|---|
| ACM-1 | None Detected |
| ACM-2 | None Detected |
| ACM-3 | None Detected |

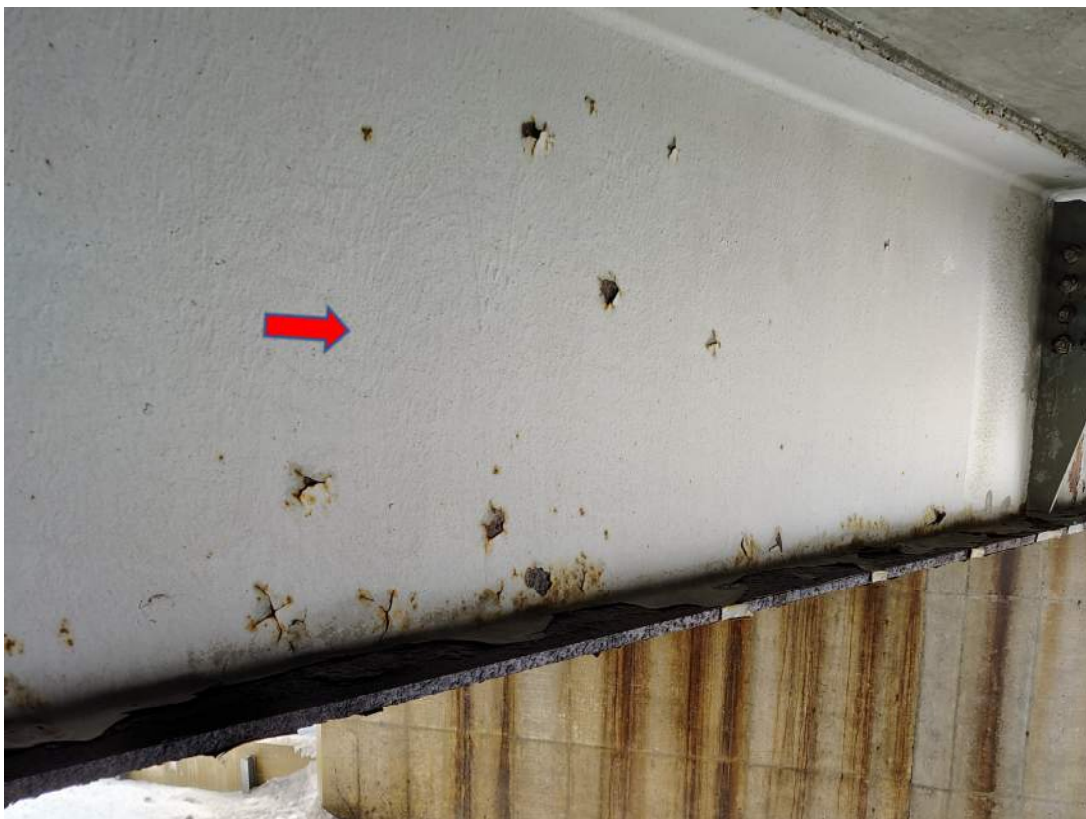
Photograph 2 – View of bridge outer girders non-ACM green/grey/white paint (ACM-4, ACM-5 & ACM-6).

| Sample ID | Percent (%) Asbestos |
|---|---|
| ACM-4 | None Detected |
| ACM-5 | None Detected |
| ACM-6 | None Detected |

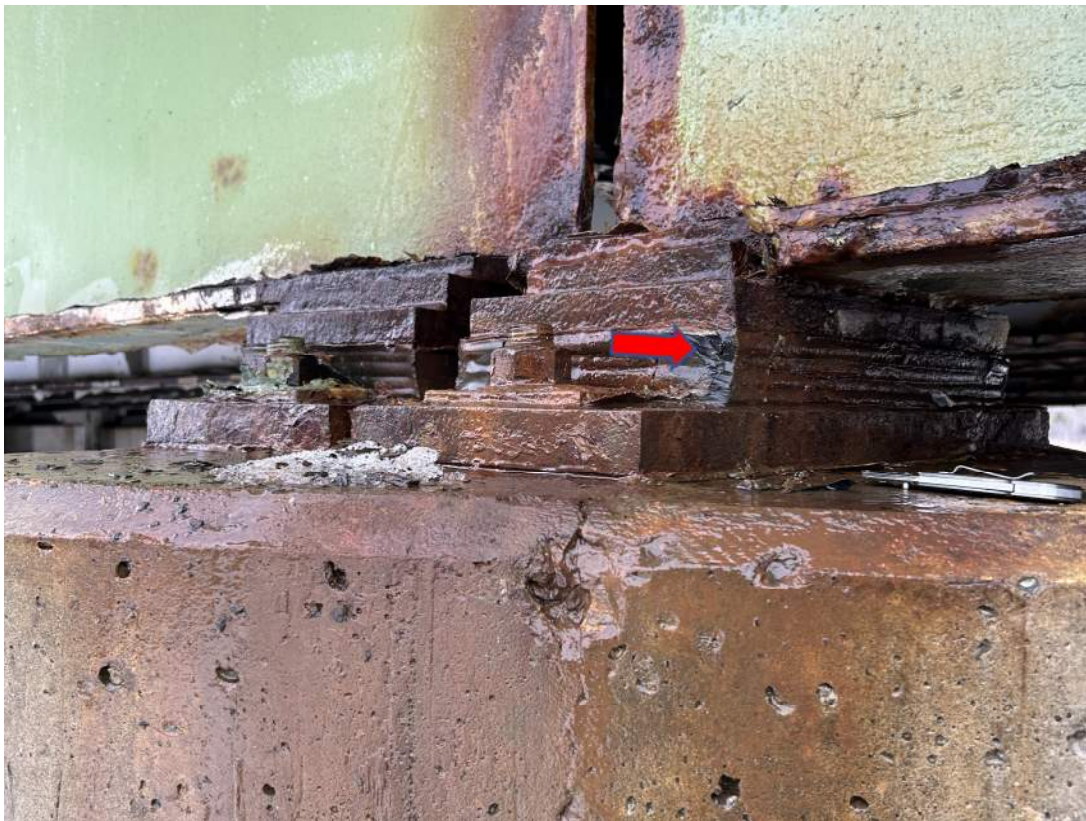
Photograph 3 – View of bridge superstructure non-ACM black bearing pads (ACM-7, ACM-8 & ACM-9).

| Sample ID | Percent (%) Asbestos |
|---|---|
| ACM-7 | N/A |
| ACM-8 | N/A |
| ACM-9 | N/A |

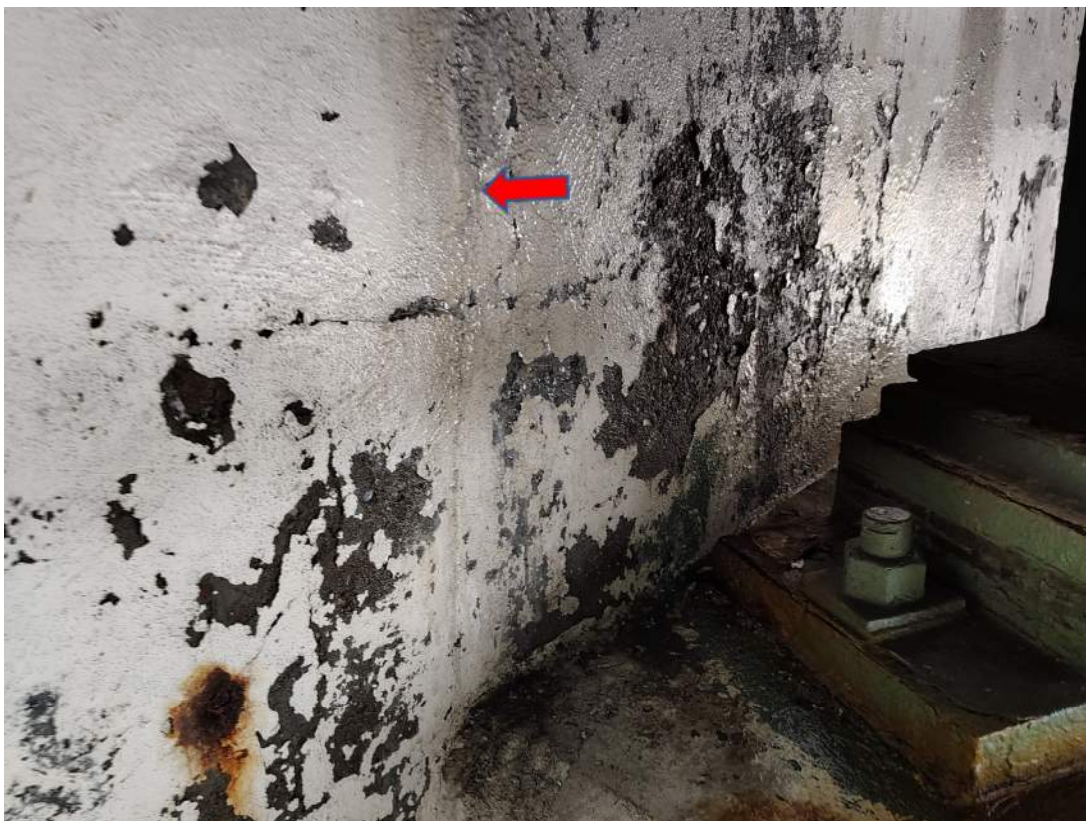
Photograph 4 – View of abutment walls non-ACM white/grey concrete protective sealant paint (ACM-12, ACM-13 & ACM-14).

| Sample ID | Percent (%) Asbestos |
|---|---|
| ACM-12 | None Detected |
| ACM-13 | None Detected |
| ACM-14 | None Detected |

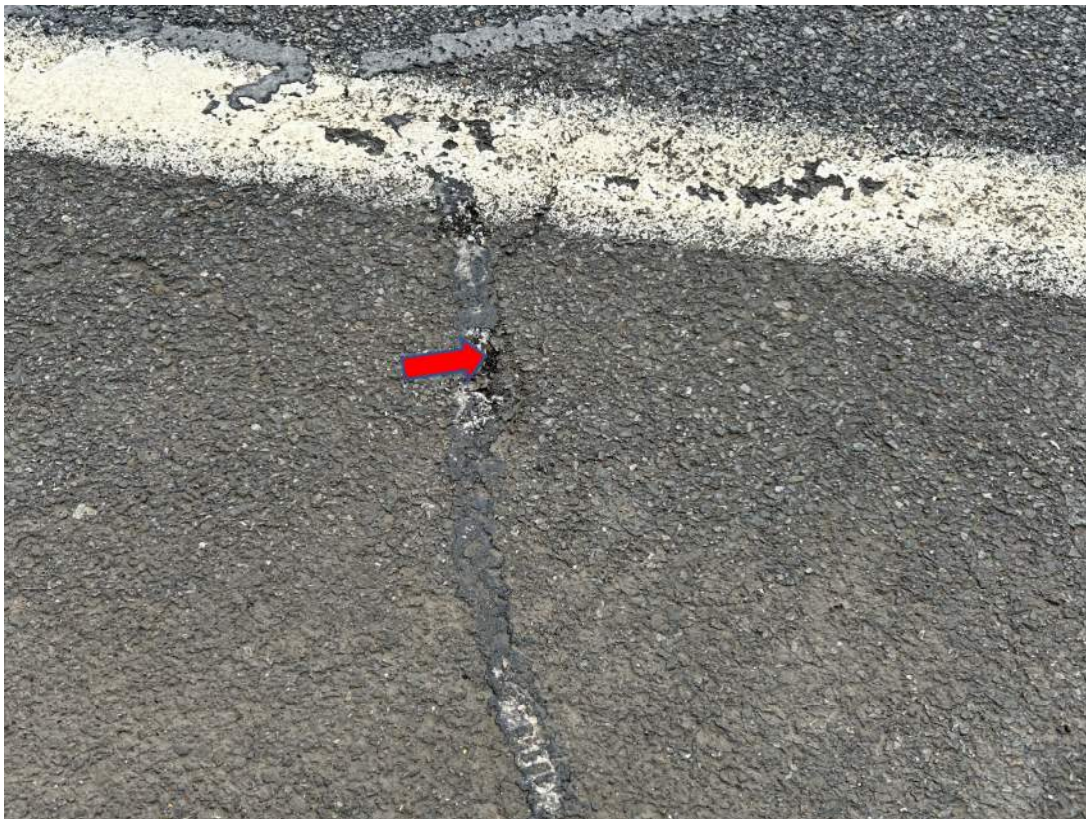
Photograph 5 – View of road surface non-ACM black asphalt/tar crack filler material (ACM-19, ACM-20 & ACM-21).

| Sample ID | Percent (%) Asbestos |
|---|---|
| ACM-19 | None Detected |
| ACM-20 | None Detected |
| ACM-21 | None Detected |

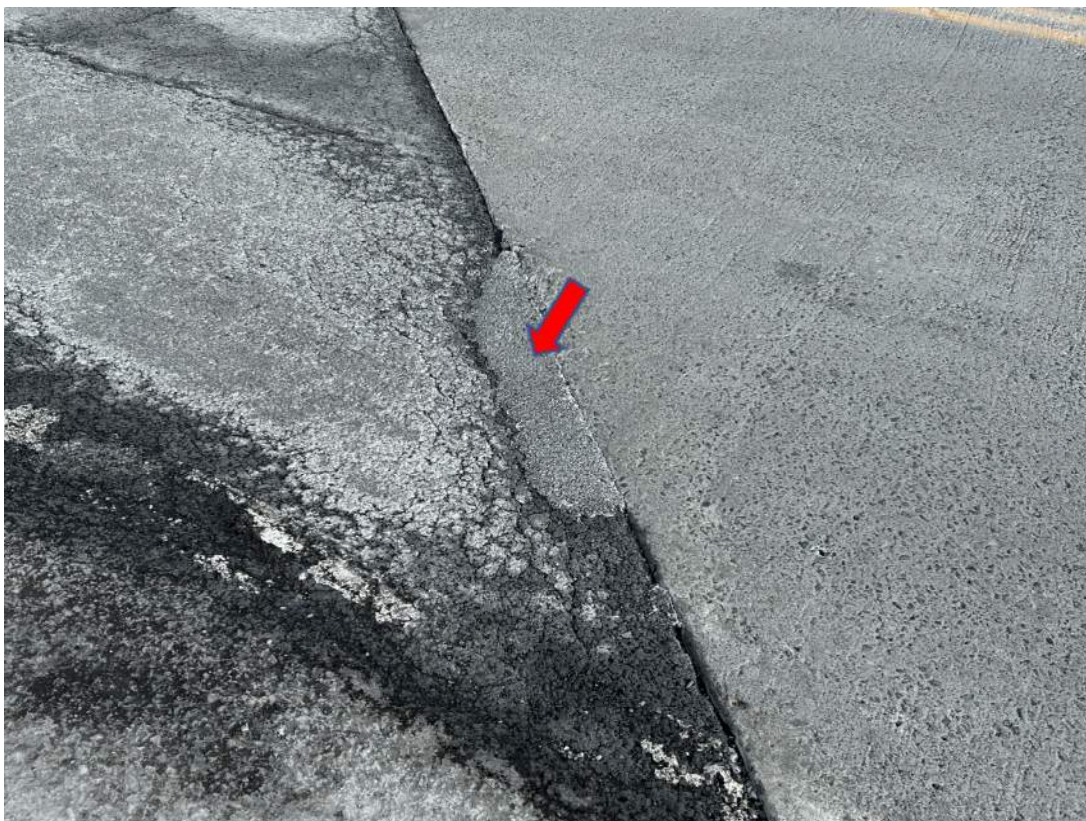
Photograph 6 – View of road surface non-ACM black asphalt patching/repair material (ACM-22, ACM-23 & ACM-24).

| Sample ID | Percent (%) Asbestos |
|---|---|
| ACM-22 | None Detected |
| ACM-23 | None Detected |
| ACM-24 | None Detected |

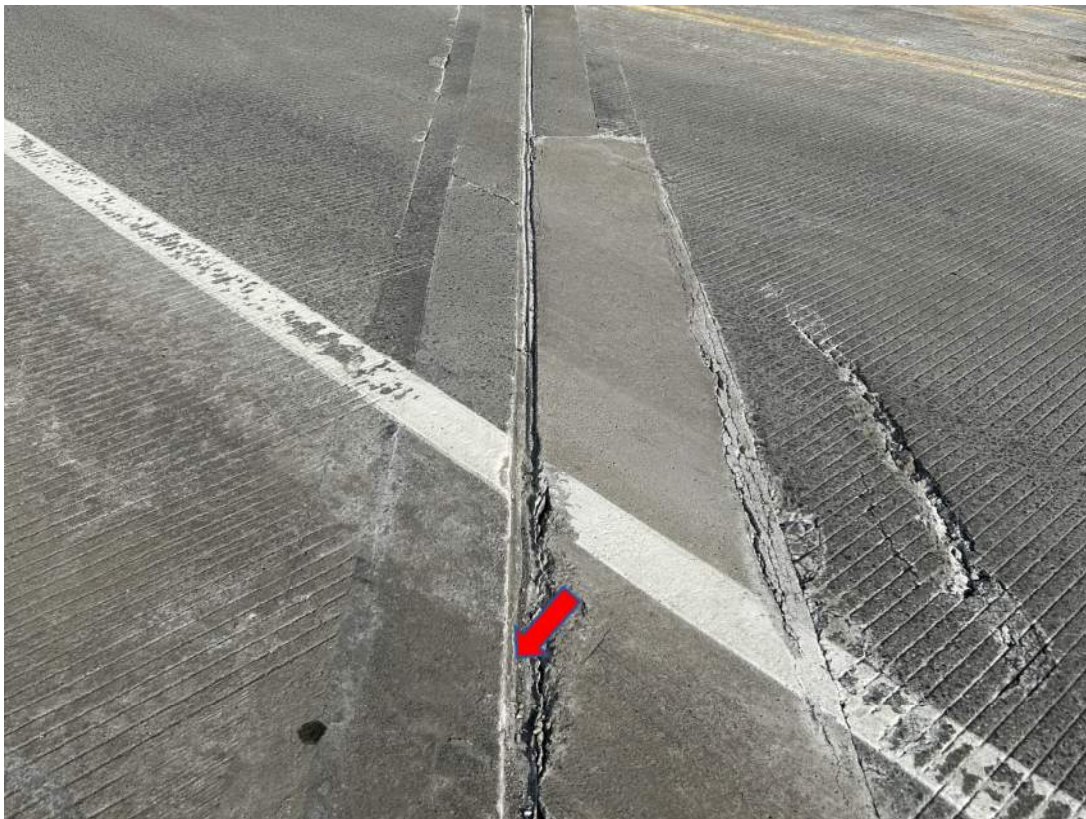
Photograph 7 – View of road surface non-ACM black expansion joint (ACM-25, ACM-26 & ACM-27).

| Sample ID | Percent (%) Asbestos |
|---|---|
| ACM-25 | None Detected |
| ACM-26 | N/A |
| ACM-27 | N/A |
