**Re: Limited Pre-Rehabilitation Asbestos Containing Materials Inspection Report  
Route 9W NB Bridge over Thruway I-87 Rehabilitation  
Town of New Baltimore, Greene County, New York**

# PHOTOGRAPHIC DOCUMENTATION

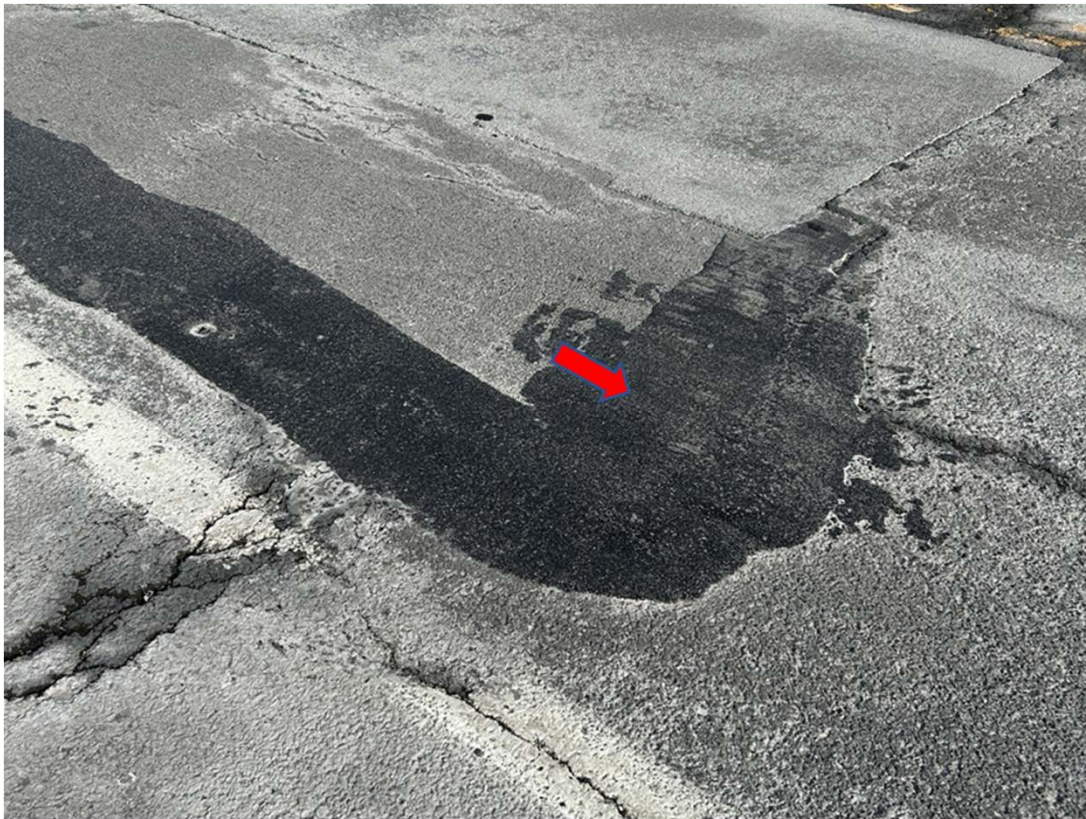
Photograph 1 – View of road surface non-ACM tar patching/repair material (ACM-5 & ACM-6).

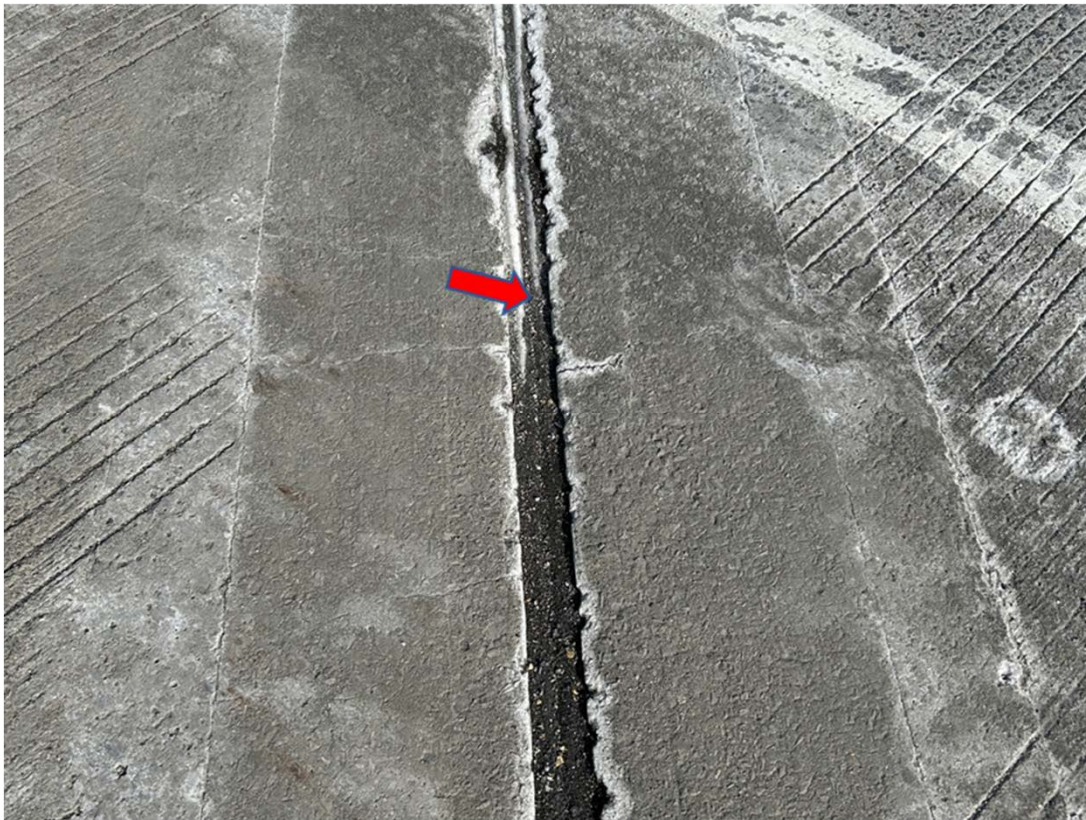
Photograph 2 – View of southbound bridge approach non-ACM grey expansion joint (ACM-7 & ACM-8).

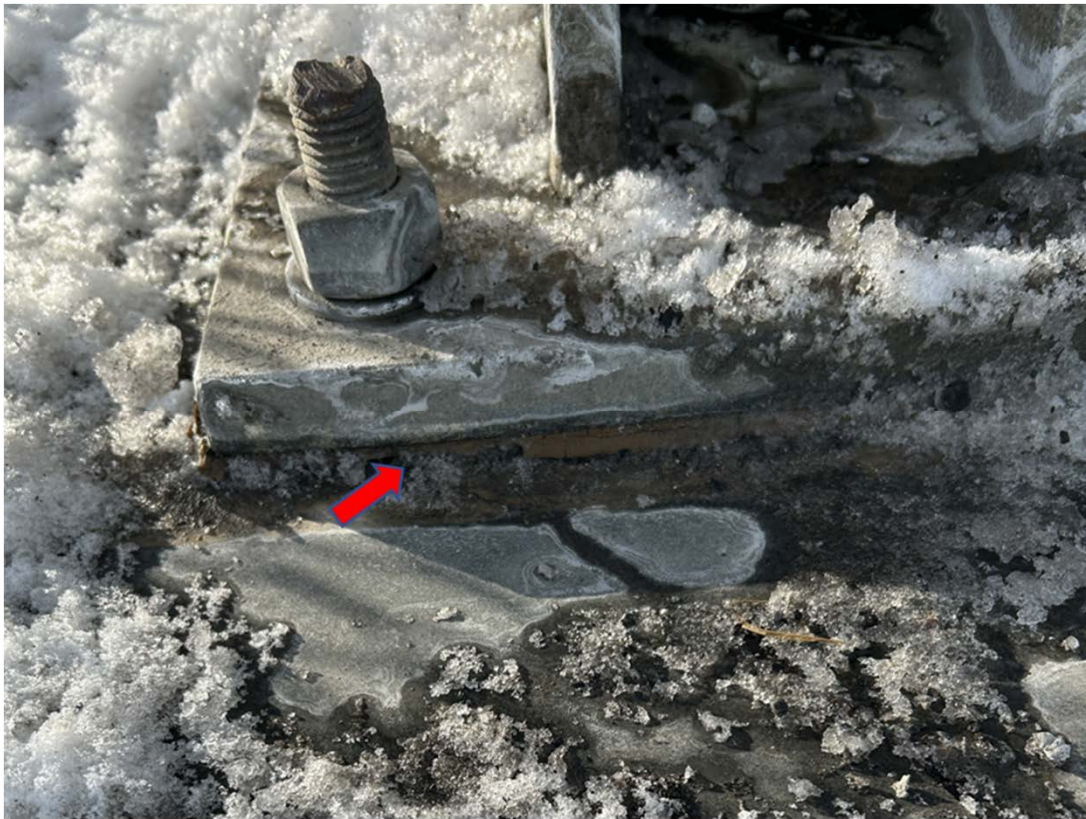
Photograph 3 – View of base of bridge railings where base plate meets sidewalk non-ACM brown/grey seam sealant caulk (ACM-9 & ACM-10).

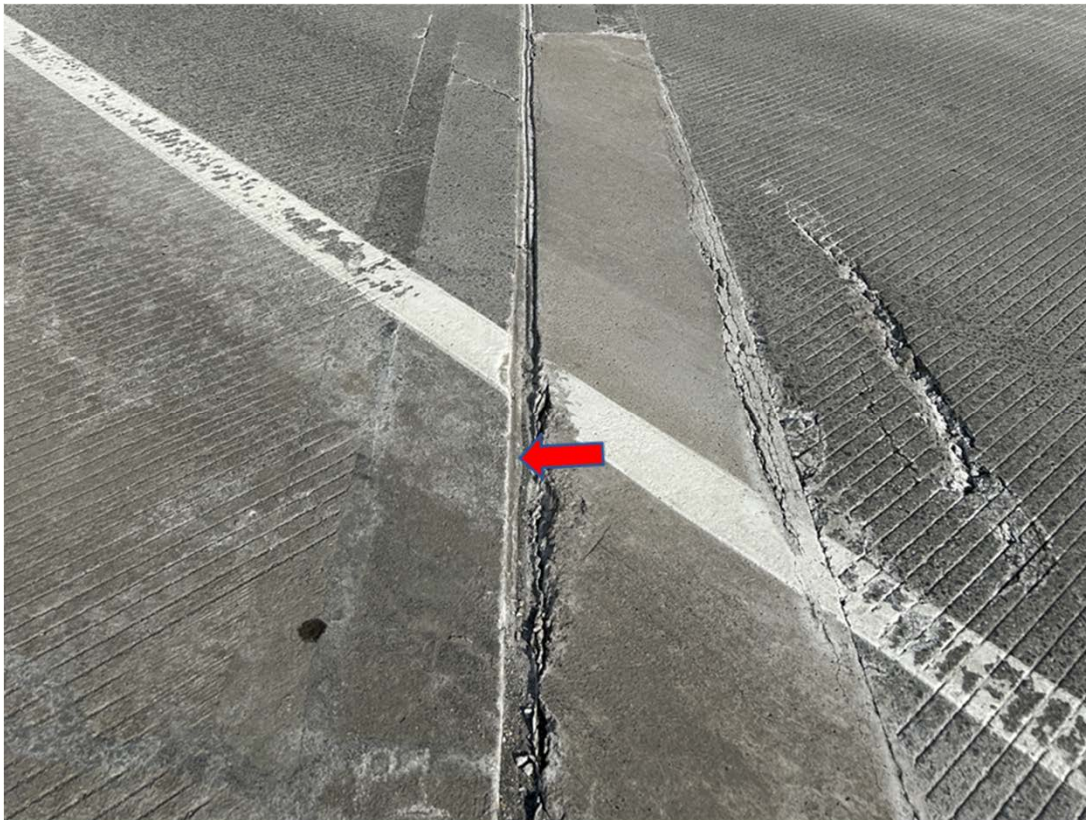
Photograph 4 – View of 2nd road seam non-ACM black expansion joint (ACM-11 & ACM-12).

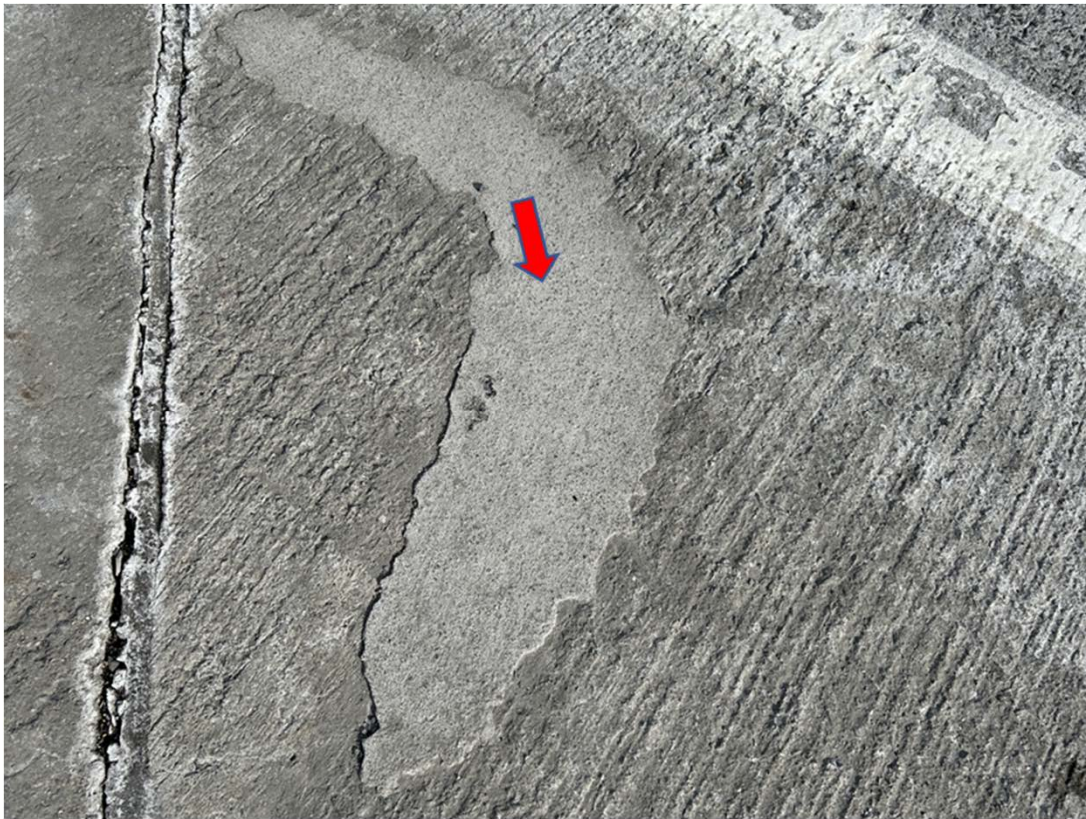
Photograph 5 – View of road surface non-ACM grey concrete patching/repair material (ACM-13 & ACM-14).

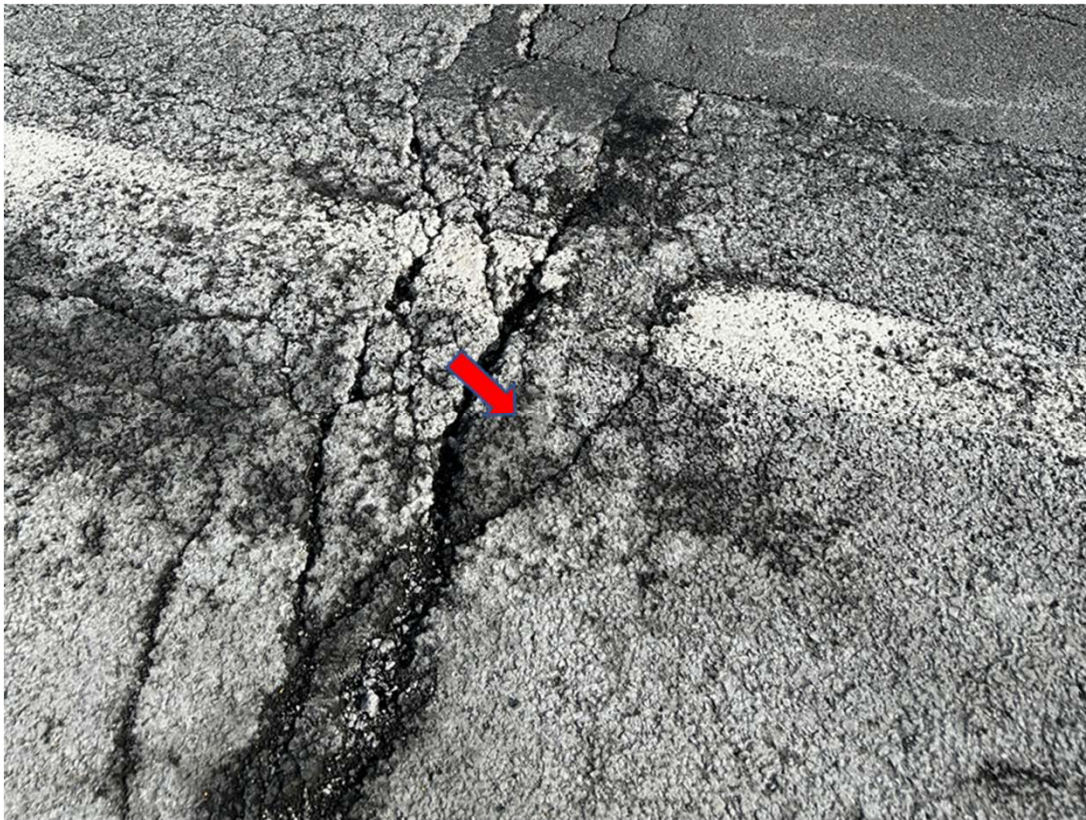
Photograph 6 – View of 2nd road surface non-ACM black asphalt/tar-like patching/repair material (ACM-15 & ACM-16).

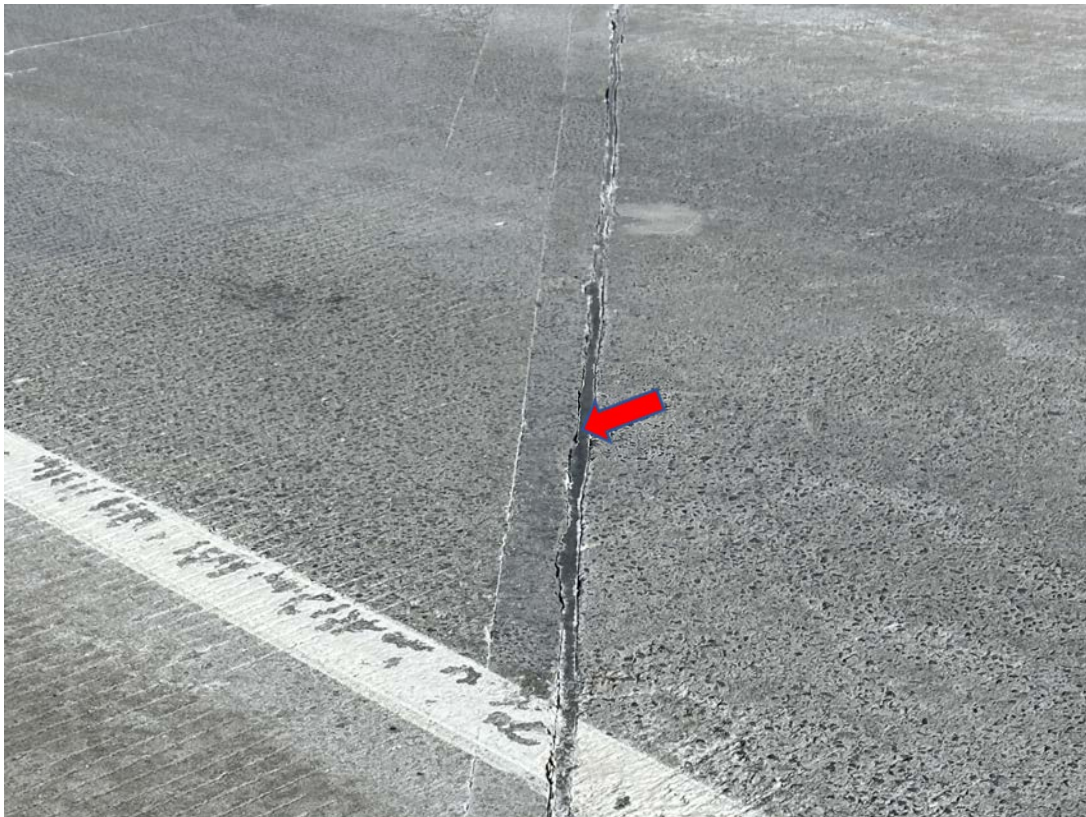
Photograph 7 – View of 3rd road seam non-ACM grey expansion joint (ACM-17 & ACM-18).

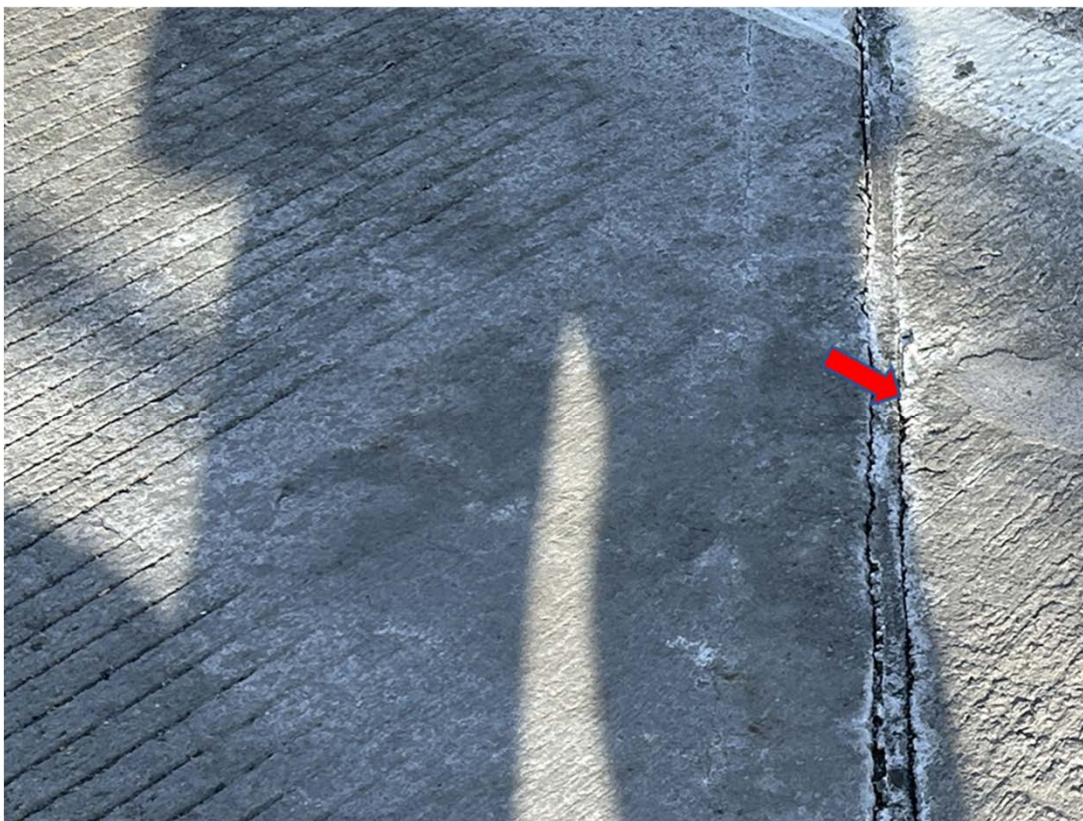
Photograph 8 – View of 4th road seam non-ACM black expansion joint (ACM-19 & ACM-20).

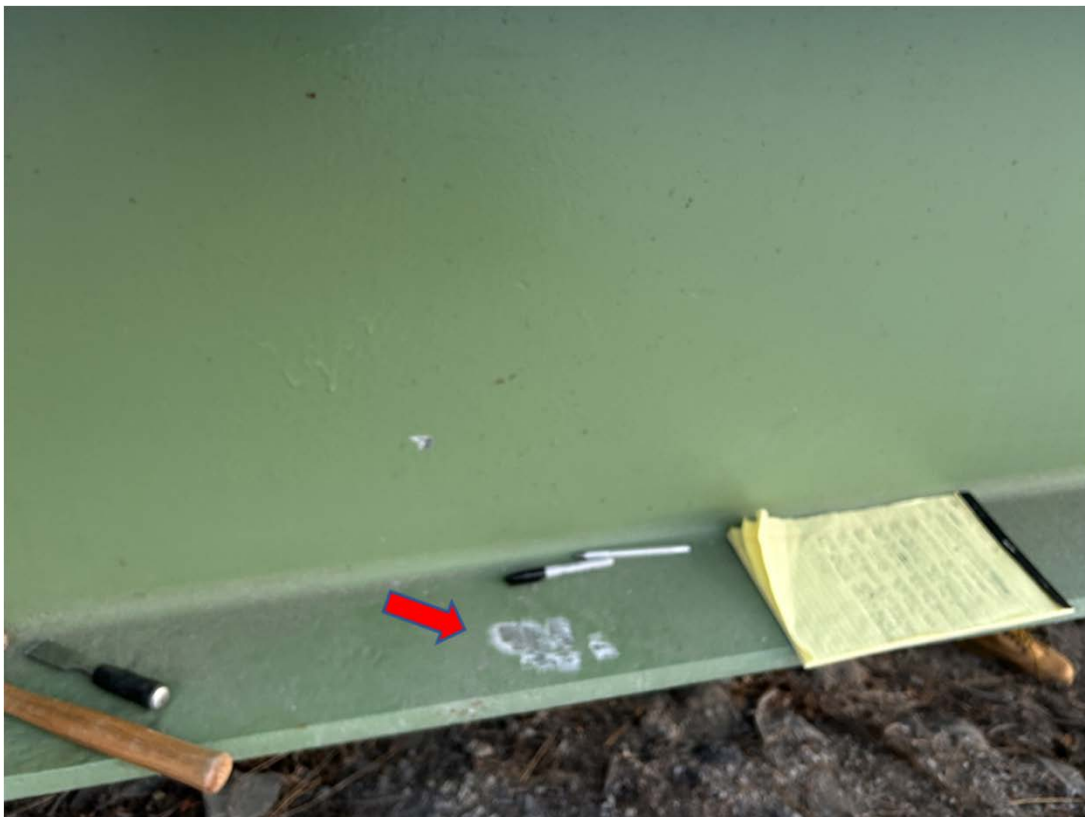
Photograph 9 – View of steel bridge girders non-ACM green paint (ACM-21 & ACM-22).

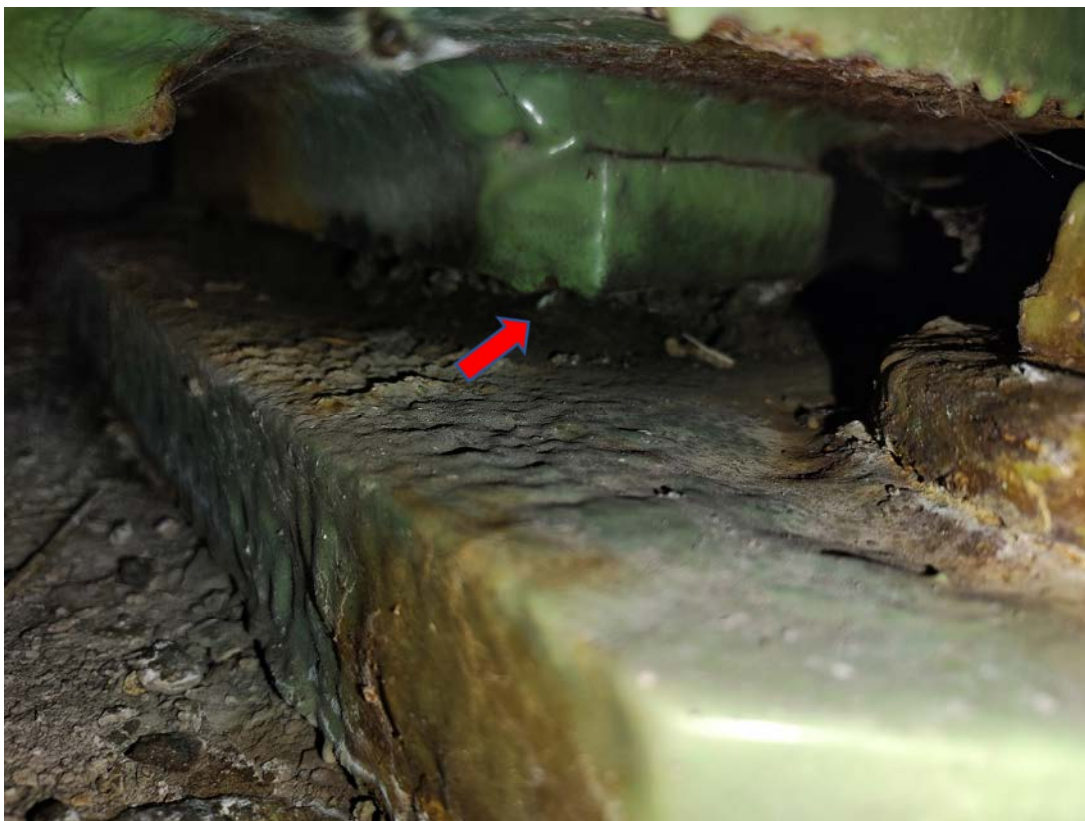
Photograph 10 – View of deck/abutment girder joints non-ACM black joint sealant material (ACM-23 & ACM-24).

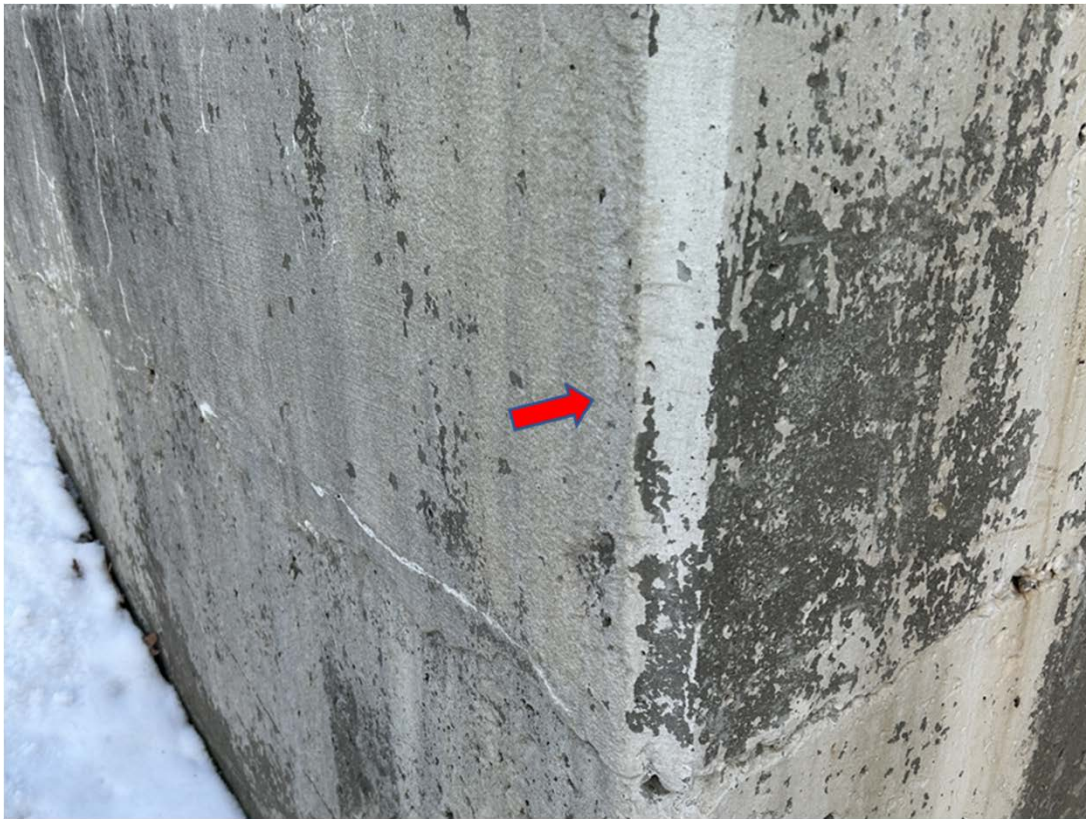
- Beige/White concrete protective coating/paint on the north, south bridge abutments, wing walls, columns and piers. ( Samples ACM-25 and duplicate sample ACM-26)

Photograph 11 – View of bridge abutment ACM beige/white paint (ACM-25 & ACM-26).

| Sample ID | Plan Sheet ID | Percent (%) Asbestos* | Quantity | Condition | Potential for Disturbance |
|---|---|---|---|---|---|
| ACM-25 | ENV-01 | 1.2% | +/- 4,000 SF | Good | Low |
| ACM-26 | | 2.5% | | | |

If bridge rehabilitation activities are planned in areas where ACMs have been identified, these materials must be removed and disposed of in accordance with regulatory standards. A NYSDOL

certified asbestos project designer, or other qualified professional must prepare a detailed asbestos abatement plan describing the required containment, removal, and disposal procedures, as well as safety measures to protect workers and the surrounding environment.

All asbestos abatement activities must be performed by NYSDOL certified asbestos abatement contractors and conducted in compliance with federal, state, and local regulations, including the OSHA Asbestos Construction Standard (29 CFR 1926.1101), USEPA NESHAP, and Code Rule 56.

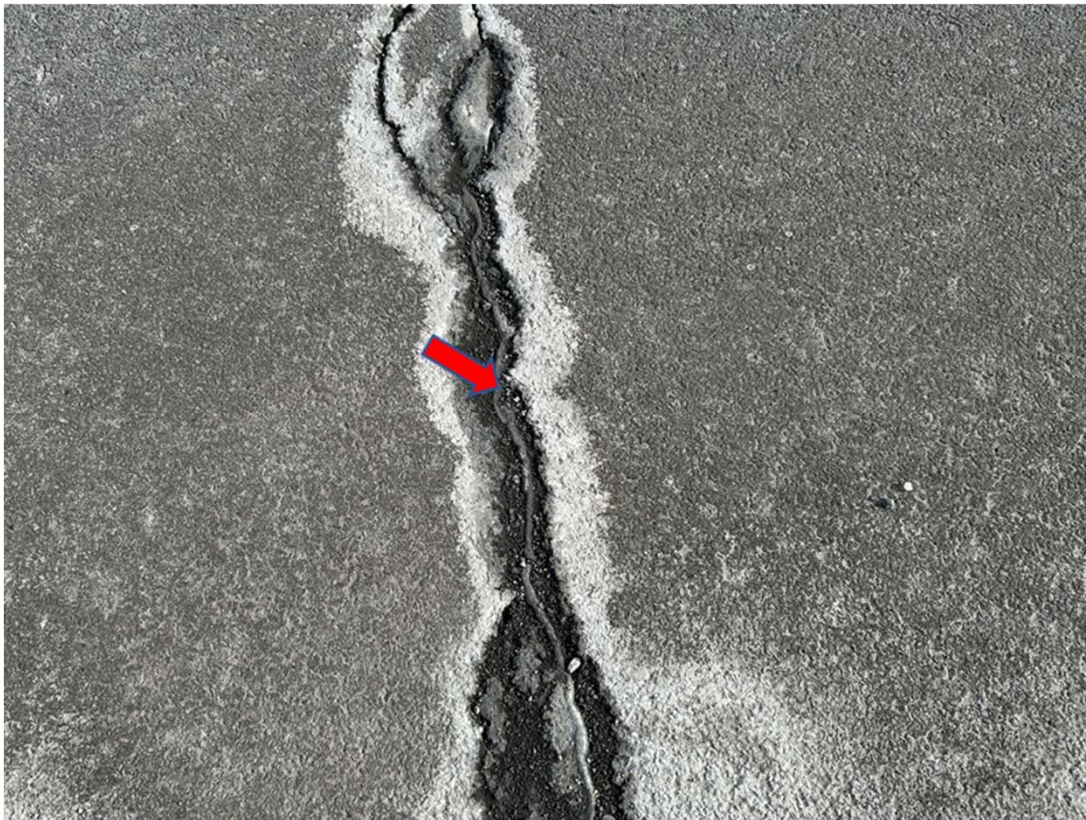
Photograph 12 – View of road surface non-ACM black crack filler/repair material (ACM-27 & ACM-28).
