# ***LIMITED HAZARDOUS MATERIALS SURVEY REPORT***

**Assignment #3 Rehabilitate the Wastewater Treatment Plants at the Port Byron and Clifton Springs Service  
Areas  
in the Syracuse Division, MP 310.2 eastbound and MP 337.1 eastbound**

**Port Byron Travel Plaza Wastewater Treatment Plant  
Mile Post 310.2  
New York State Thruway  
Port Byron, New York**

March 8, 2017

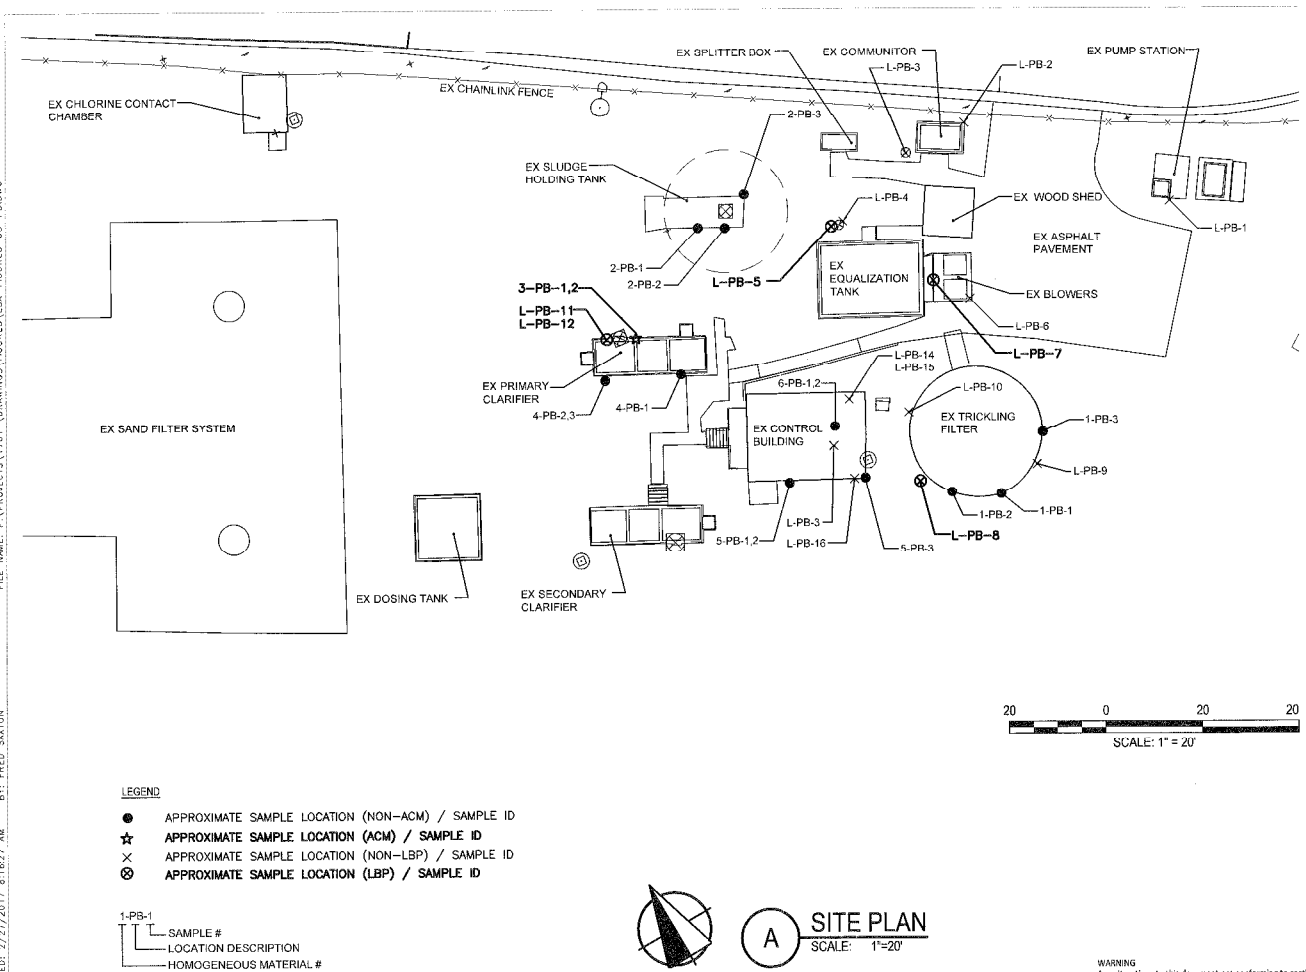
FIG-2

| PORT BYRON WWTP SAMPLED MATERIALS | | |
|---|---|---|
| <b>Notes:</b><br><sup>1.</sup> Homogeneous material number corresponds to the first set of numbers in Sample ID on Chain of Custody provided in Report Attachment A.<br><sup>2.</sup> Refer to Figure 2 for sample locations. | | |

| PORT BYRON: SUMMARY OF ANALYTICAL RESULTS | | | | |
|---|---|---|---|---|
| 3-PB-1 | Primary Clarifier panelboard at scum and sludge collection control equipment | Gray panelboard | PLM | 16.70% Chrysotile |

| PORT BYRON: SUMMARY OF ASBESTOS-CONTAINING MATERIALS | | | |
|---|---|---|---|
| Gray Panelboard | Primary and Secondary Clarifier at scum and sludge collection control equipment | 8 SF<br>(4 SF each) | Good |
